# **Final Report**

## **COLLISION BETWEEN HAFNIA NILE AND CERES I AT SOUTH CHINA SEA ON 19 JULY 2024**

TIB/MAI/CAS.173

Transport Safety Investigation Bureau  
Ministry of Transport  
Singapore

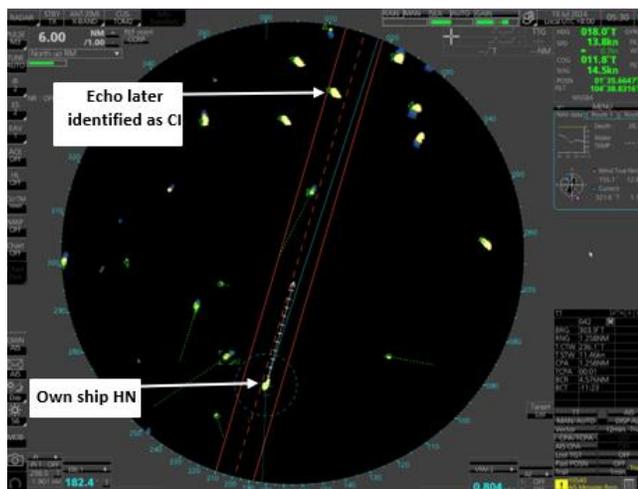
- 1.1.1.18 By about 0509H, HN-2M ordered a further course change to 014°. Once steadied, the autopilot was re-engaged. At about 0518H, HN-2M adjusted the course to the planned 017°.
- 1.1.1.19 At approximately 0520H, HN-2M altered course to 026°, to allow the ship on the starboard bow to cross ahead. The ship passed at 0531H at a distance of approximately 1.2nm. At about 0526<sup>20</sup>H, HN-2M adjusted the course back to the planned track at 018°.
- 1.1.1.20 At around 0530H, HN-ASD2 reported several targets ahead. HN-2M consulted the X-band radar and visually identified a ship directly ahead, about 7.6nm away, with deck lights and without navigation lights, later identified as CI. Two additional ships on reciprocal courses were seen on the starboard bow. HN-2M decided to maintain the current course of 018° to allow them to pass safely. See **figure 1**.

Figure 1: X-band radar display at 0530H. (Source: HN-Company and annotation by TSIB)

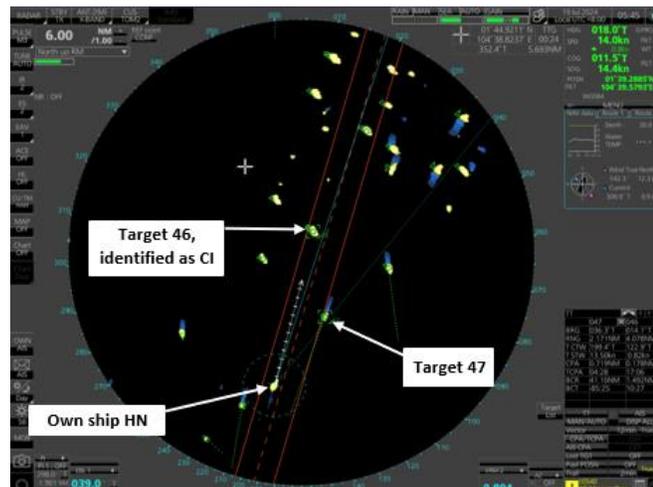
- 1.1.1.22 By about 0545H, CI was acquired on X-band ARPA, showing a CPA of 0.18nm in 17 minutes. HN-2M informed HN-ASD2 that after the ship, identified as Target 47 had passed on HN's starboard side, a course change would be made to increase CPA from CI ahead. At that time, several radar targets had already been acquired, including CI. However, according to HN-2M, he did not take note of the target data, including CPA and TCPA. HN-2M then entered the chartroom again, see **figure 2**.

Figure 2: X-band radar display at 0545H. (Source: HN-Company and Annotation by TSIB)

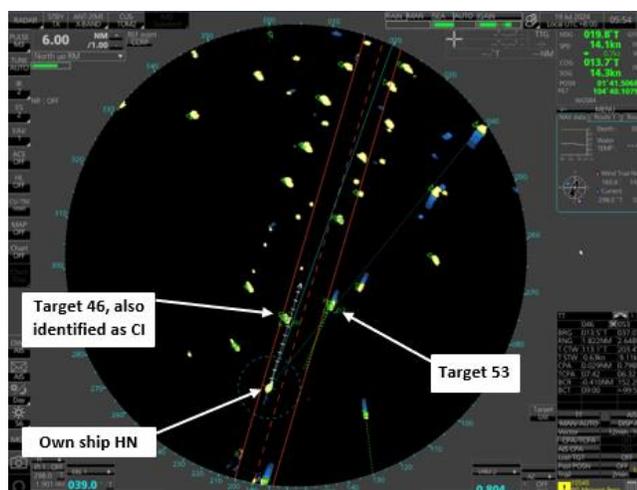
- 1.1.1.24 At about 0554H, after confirming that HN would pass ahead of CI by less than 200m, HN-2M observed another radar target, Target 53, about two points on the starboard bow, with CPA of eight cables in six minutes. At that time, HN-2M intended to have HN pass between CI and Target 53, which were approximately 0.7nm apart from each other. See **figure 3**. HN-2M then returned to the chartroom.

Figure 3: X-band radar display at 0555H. (Source: HN-Company and annotation by TSIB)

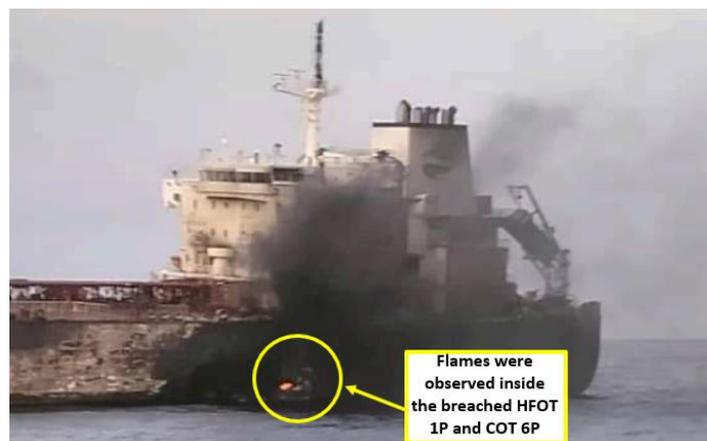
- 1.1.2.3 The fire, which broke out immediately after the collision, spread across both ships and the surrounding sea surface. See **figure 4**.

Figure 4: Photograph taken later in the day shows residual fire and smoke originating from HN's breached HFOT 1P and COT 6P. (Source: CI-Company and annotation by TSIB)

- 1.1.3 Damage assessment of HN
  - 1.1.3.1 Assessments indicated breaches to the hull in the area of COT 6P and HFOT 1P, contributing to post-collision fire and structural damage.

- 1.1.3.2 The hull breaches resulted in the loss of approximately 4065.44 MT of naphtha cargo from COT 6P and approximately 565 MT of Very Low Sulphur Fuel Oil (VLSFO) from HFOT 1P. **Figure 5** shows a portion of the VLSFO leaked into the sea. The contaminated oil-water mixture was later collected using a slop barge.

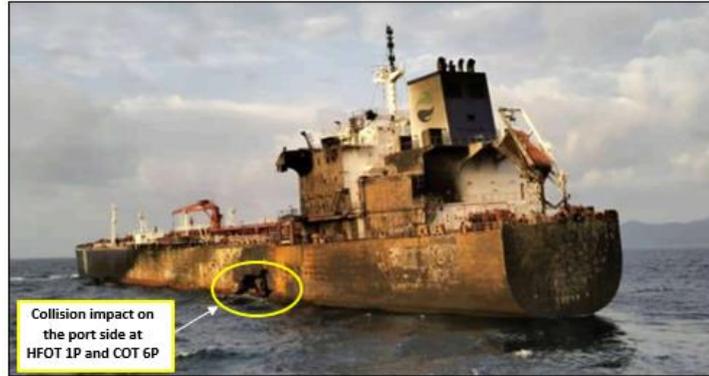
Figure 5: Image of the ship showing collision impact and subsequent fire damage. (Source: HN-Company and annotation by TSIB)

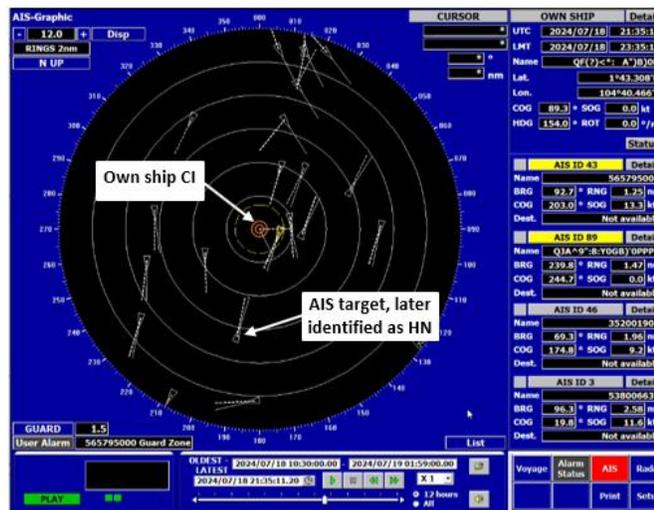
The bridge team continued to monitor HN's movement along with other nearby ships. See **figure 6**.

Figure 6: X-band radar screenshot with AIS overlay. (Source: MMD<sup>35</sup> and annotation by TSIB)

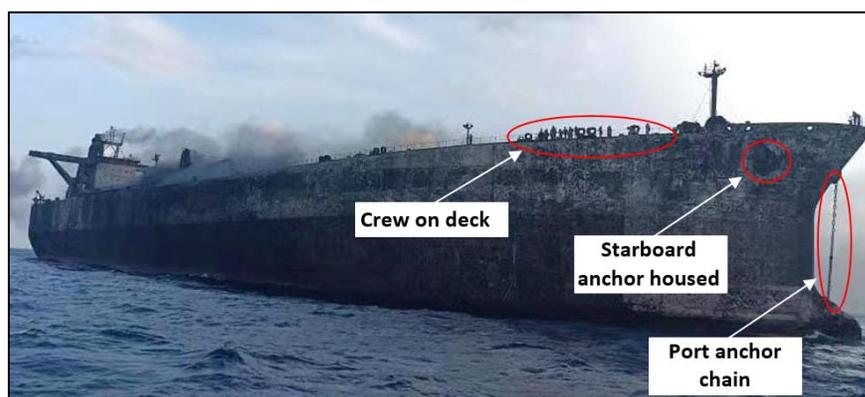
1.2.2.8 At approximately 0930H, after transferring all the shore workers, CI-Master ordered all crew to withdraw to the forecandle area as a safety measure against potential flare-ups. **Figure 7.**

Figure 7: CI with the port anchor chain parted, starboard anchor housed, crew on deck, residual smoke, and fire damage to the hull and superstructure.

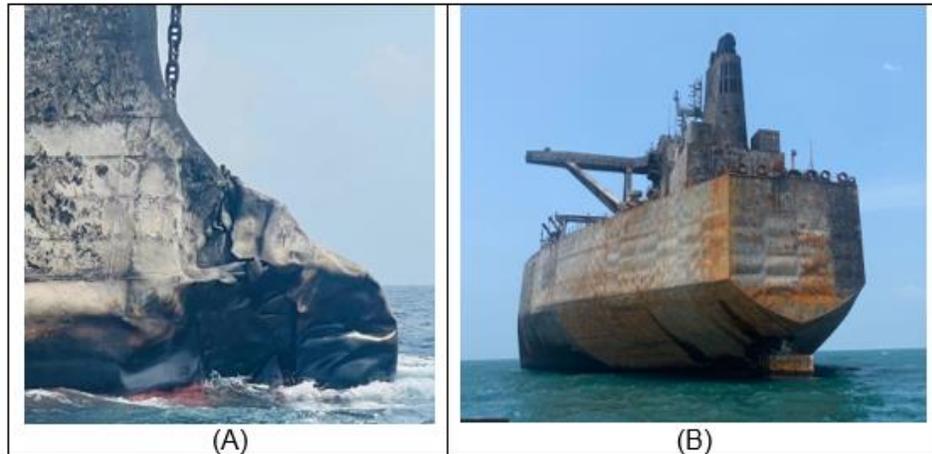
- 1.2.4 Damage assessment of CI
- 1.2.4.1 Initial assessments identified extensive fire damage to the ship's hull and superstructure. Notable losses included both the port and starboard cranes, the lifeboat, and the liferafts.

- 1.2.4.2 Additional damage included a completely burnt bosun store on the starboard side and partial fire damage on the port side. The port anchor and eleven shackles of chain were lost, and the port anchor chain stopper was damaged. Further damage included a burnt steering gear room, a damaged freshwater generator, and auxiliary engine No.2 generator. The main engine could not be turned, and its operational status remained uncertain (See **figure 8**). A complete damage assessment was not available at the time of publishing this report.

Figure 8: Images A and B of CI showing the damaged bow section (A) and fire damage of the hull and superstructure (B). (Source: CI-Company)
